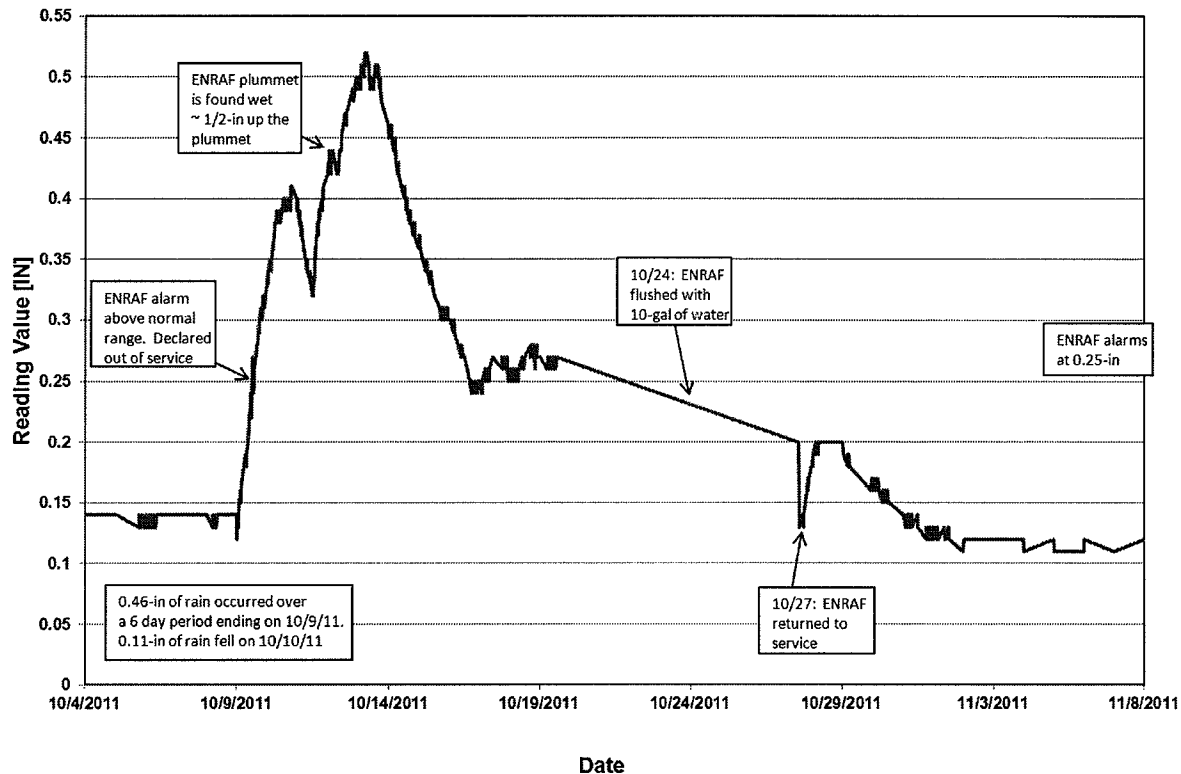
**Figure 4-28. Tank AY-102 Riser 90 Annulus ENRAF 152 Liquid Levels October 2011**

Beginning on October 9, 2011, ENRAF 152 levels began to slowly increase from 0.26 in. to a maximum value of 0.51 in. on October 13, 2011. Levels then gradually declined to less than 0.25 in. by October 27, 2011. Figure 4-28 shows SDDS data for the October 4, 2011 to November 8, 2011 time period.

Prior to October 9, 2011, 0.46 in of rain occurred over a 6 day period and an additional 0.11 in. of rain fell on October 10, 2011 (Hanford Meteorological Station, October 2011 Monthly Summary). An increase in liquid level and high-level alarm at TMACS occurred on October 9, 2011 for ENRAF 152 (WRPS-PER-2011-2120). On October 12, 2011 it was determined ENRAF 152 was working properly and the plummet was found wet approximately ½ in. up the plummet with a radiation dose rate of 2 – 4 mrem/hr through the sight glass enclosure (see Figure 4-27). Rainwater intrusion was thought to be the cause of the wetness (TOC-ENV-NOT-2011-0012). On October 24, 2011 the ENRAF was again flushed with water. The dose rate on the plummet was 5 mrem/hr before flushing and 1.5 mrem/hr afterwards. As a result of these events, it was recommended that a camera be inserted into the annulus to see if the suspected water intrusion could be pinpointed (WRPS-PER-2011-2120). However, a camera was not inserted into the annulus space until August 2012 (see Sections 4.1.7 and 4.2.6). Table 4-18 provides the chronology of events between the alarm on October 9, 2011 and the ENRAF 152 return to service on October 27, 2011.
